RATHGEBER/GOSS ASSOCIATES

RE: Equestrian Center at Avenel - Barn Assessment
10010 Oaklyn Drive
Potomac, MD 20854

GENERAL DESCRIPTION

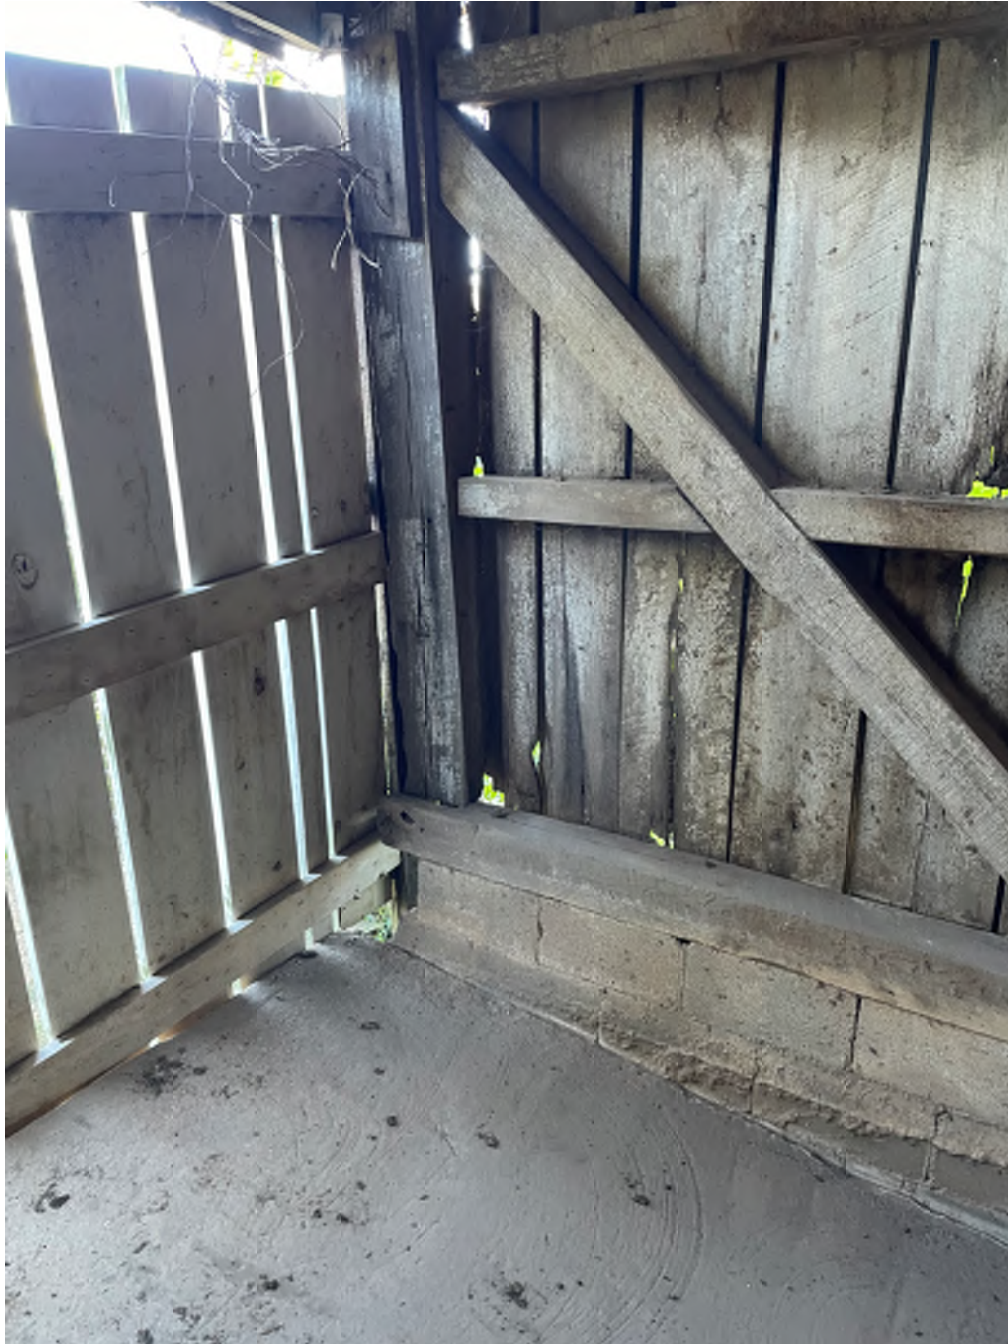
Rotten members at the north west end.

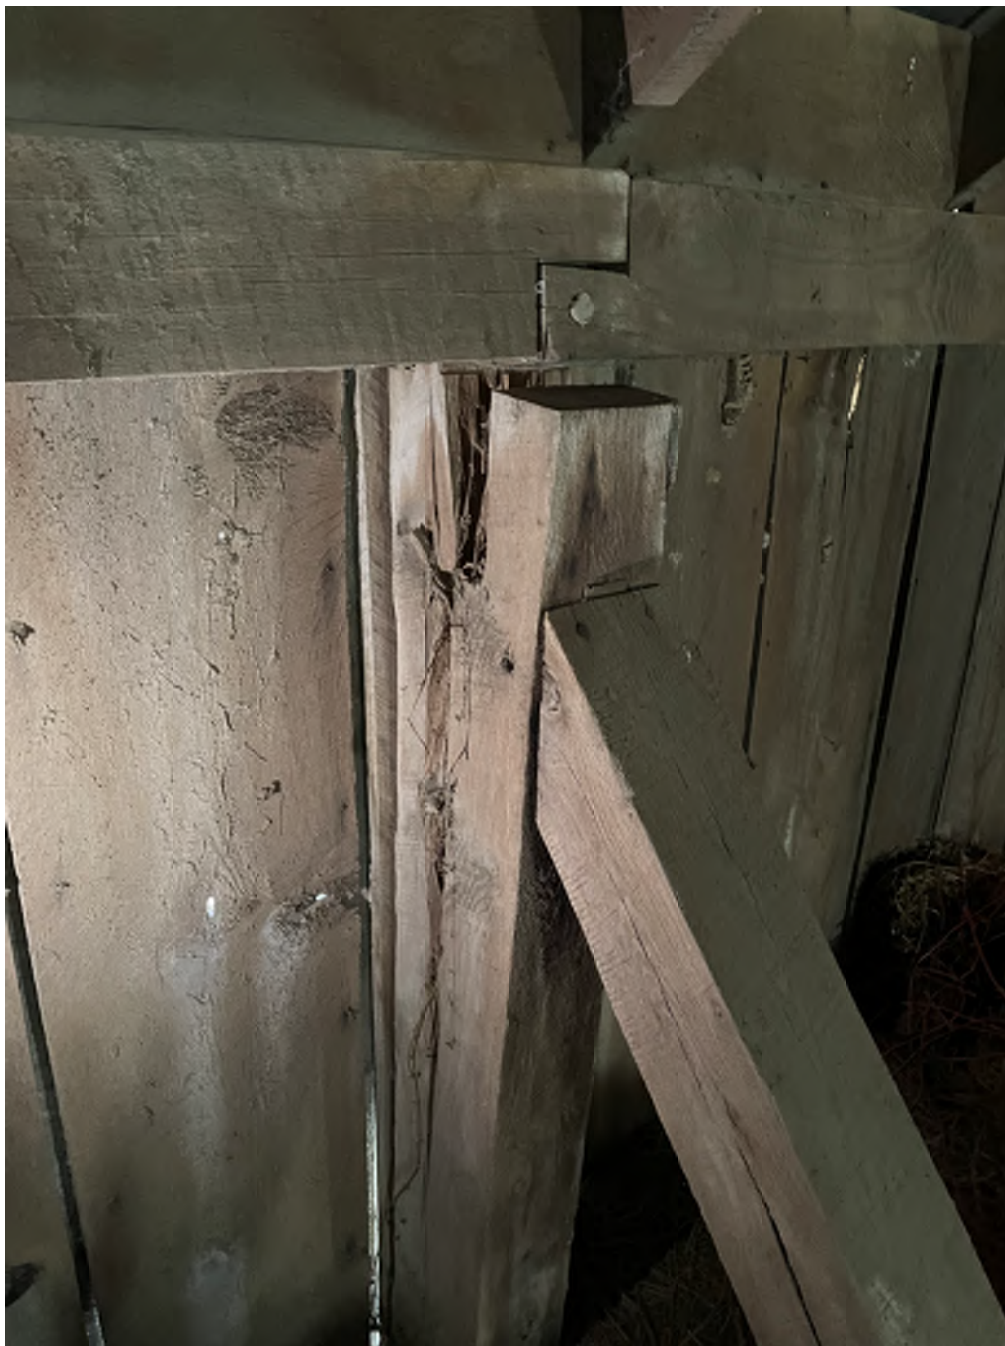
Damaged post in loft

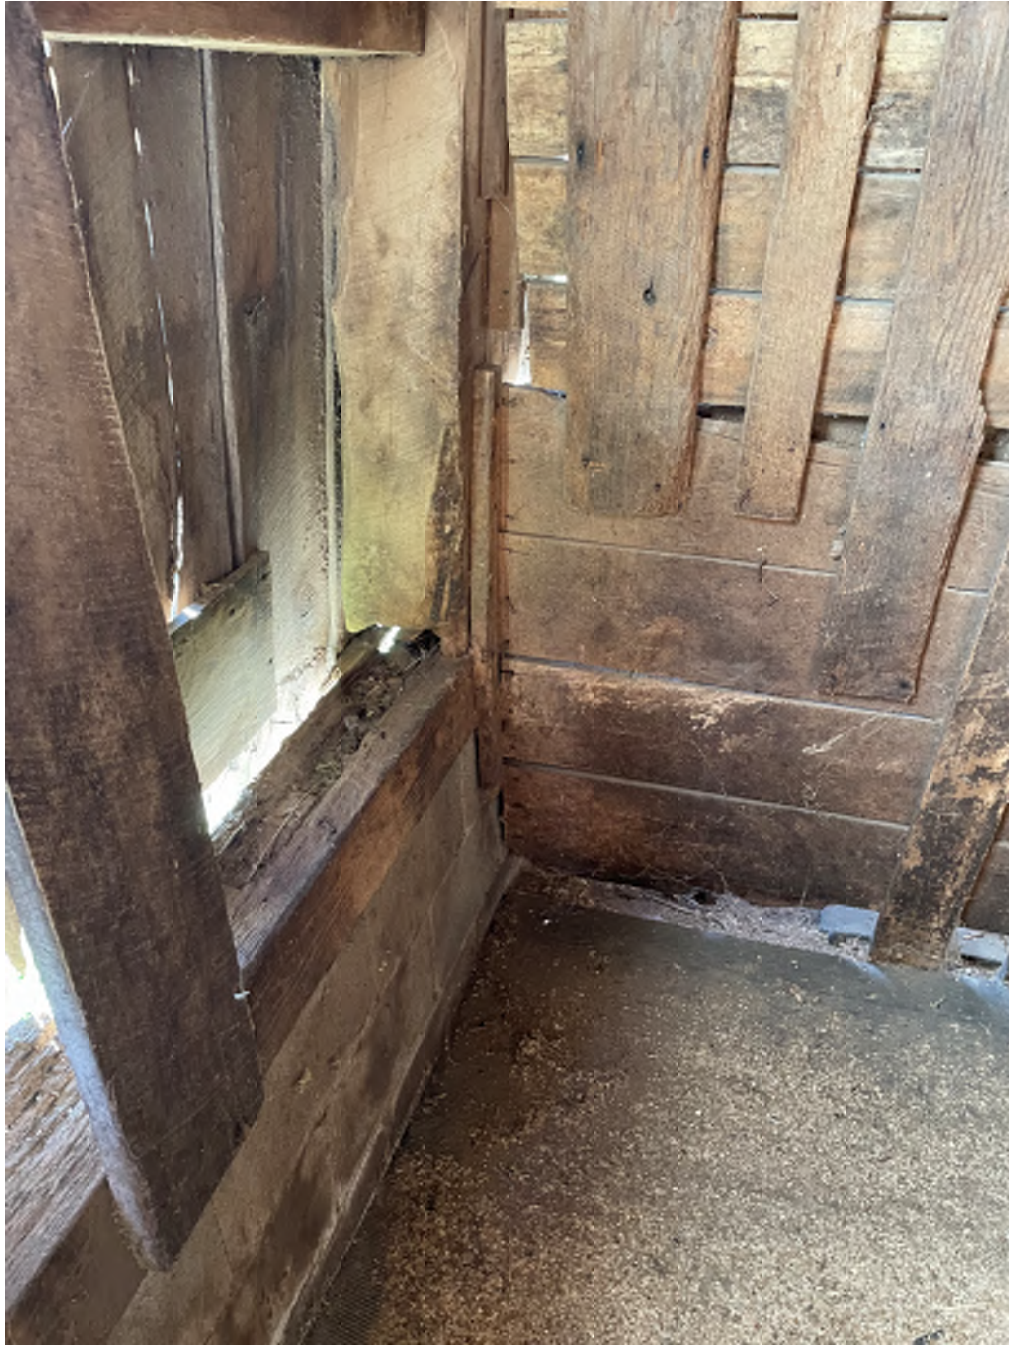
Additional Rotten post.

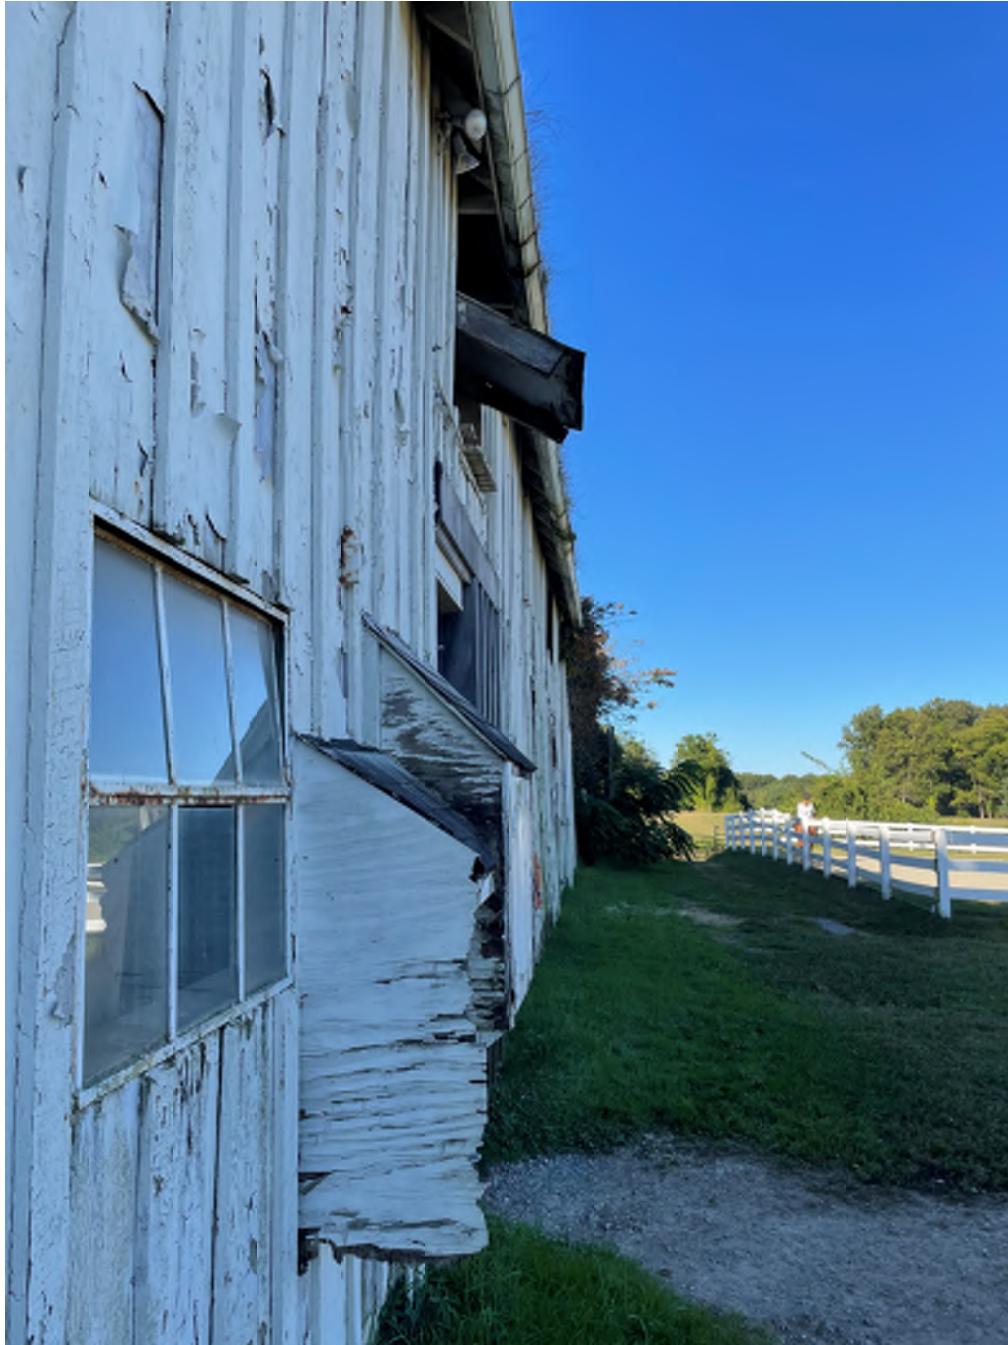
Leaning to left in photo (south). Note vegetation.

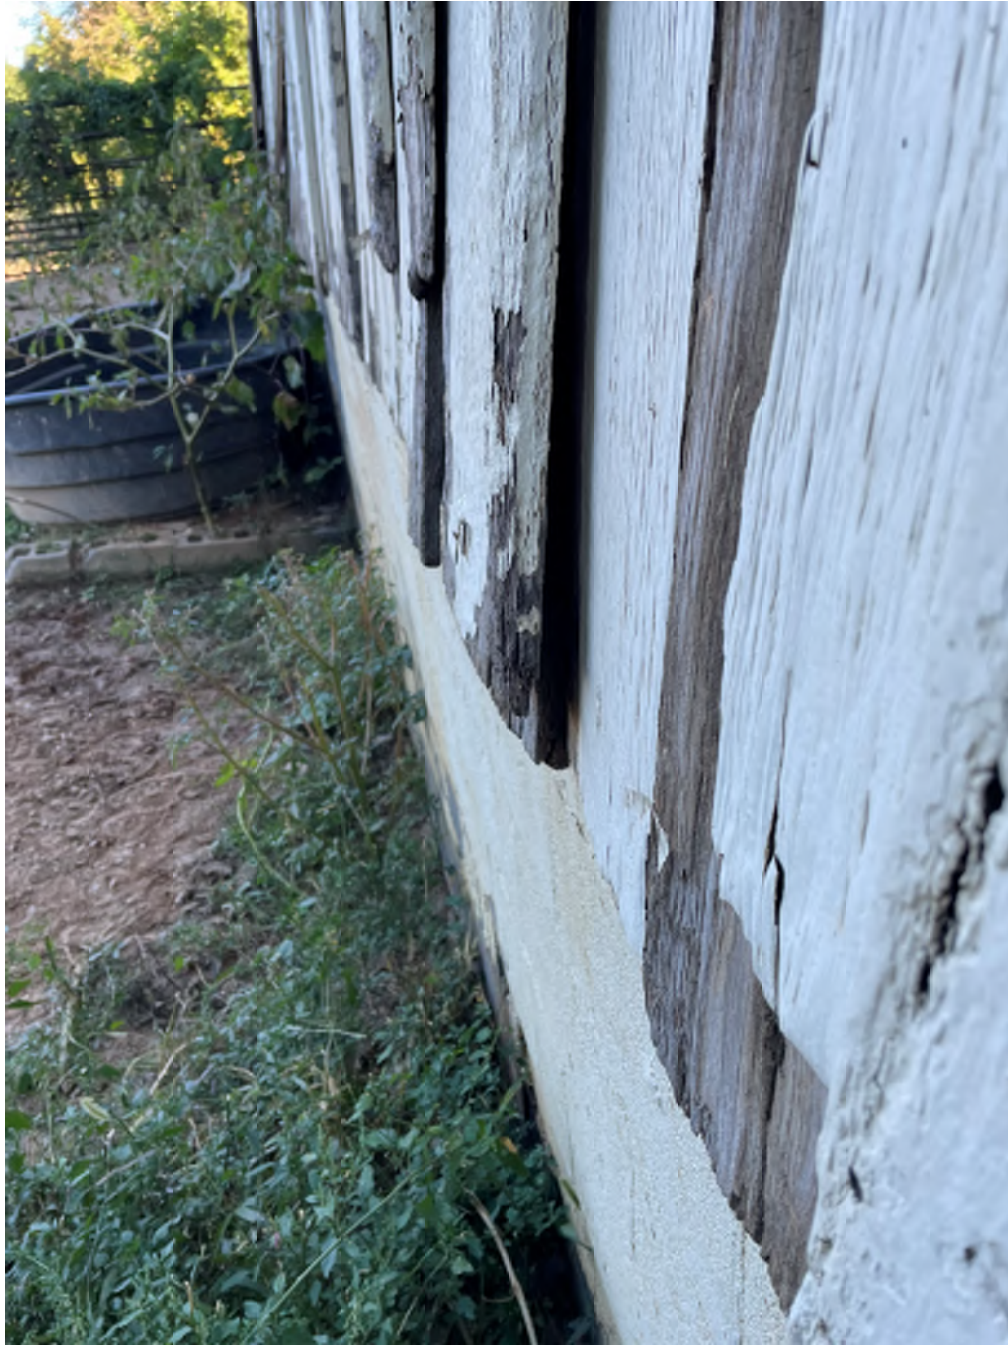
West foundation wall is a retaining wall and leaning outward.

- Remove vegetation from the exterior of the barn and replace rotten/damaged siding.
- Inspect the barn for additional rotten/damaged members and repair/replace.
- Repair any roof leaks.
- Stabilize the leaning retaining wall at the west end and repair the heaved slab at the door.

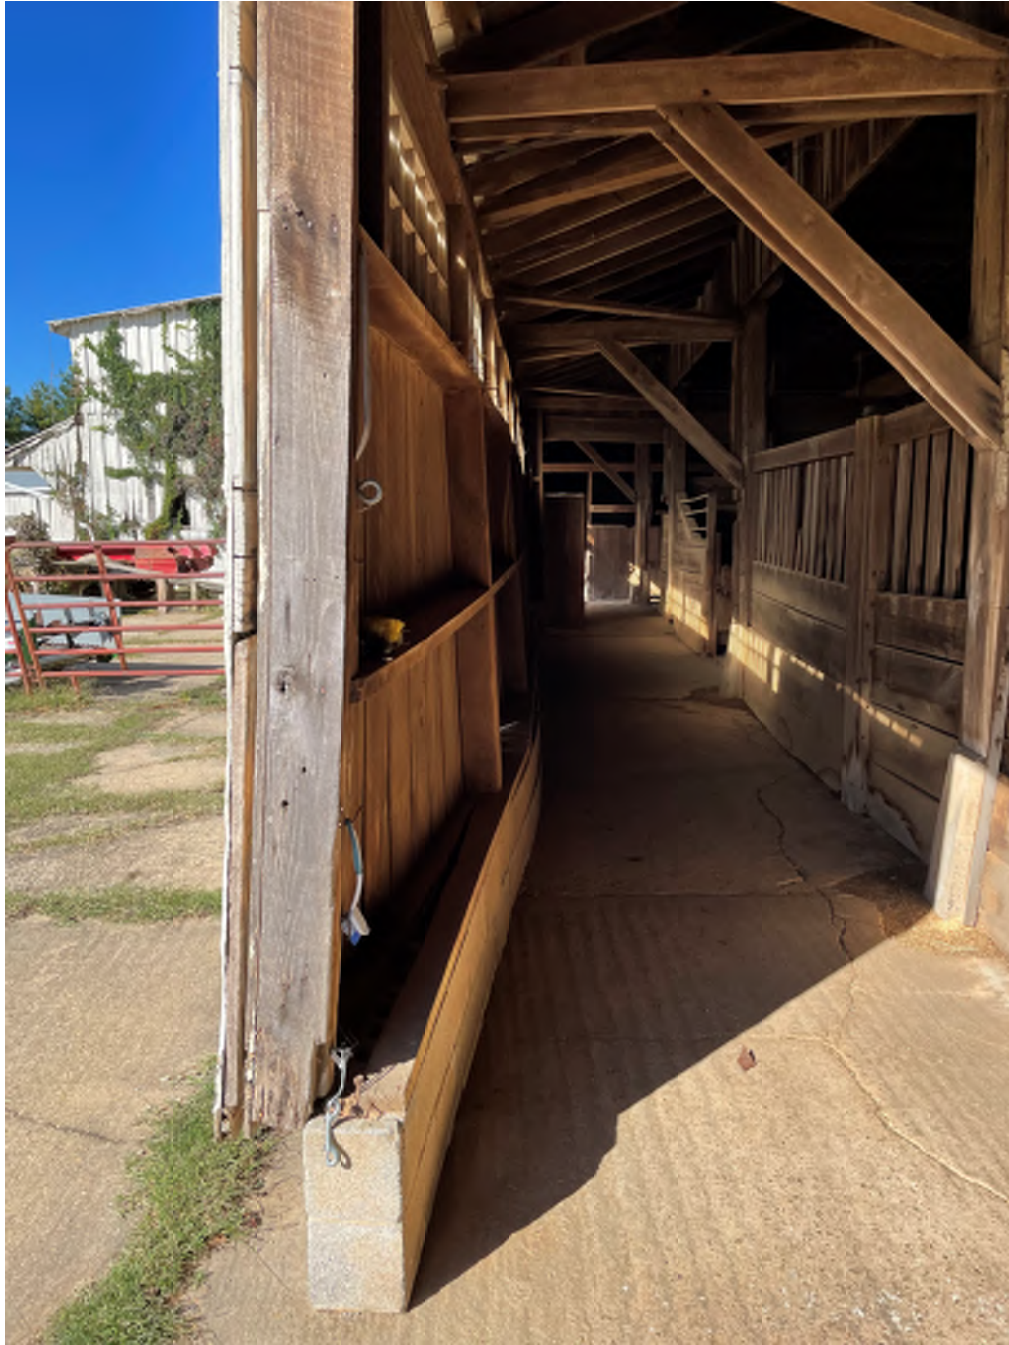
South west foundation wall out of place.

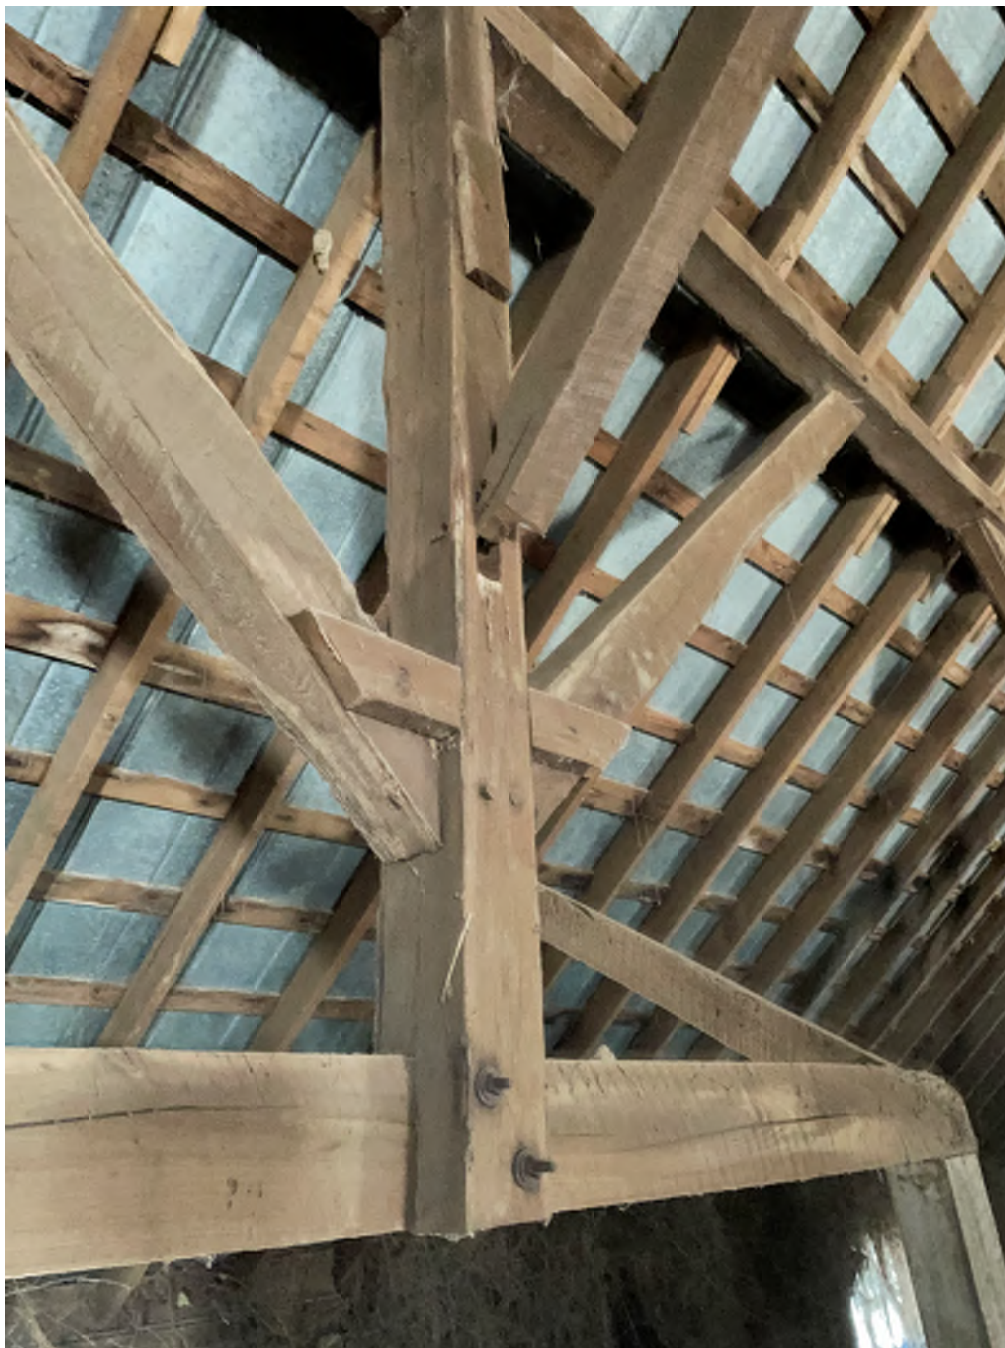
Transferred post to be stabilized.

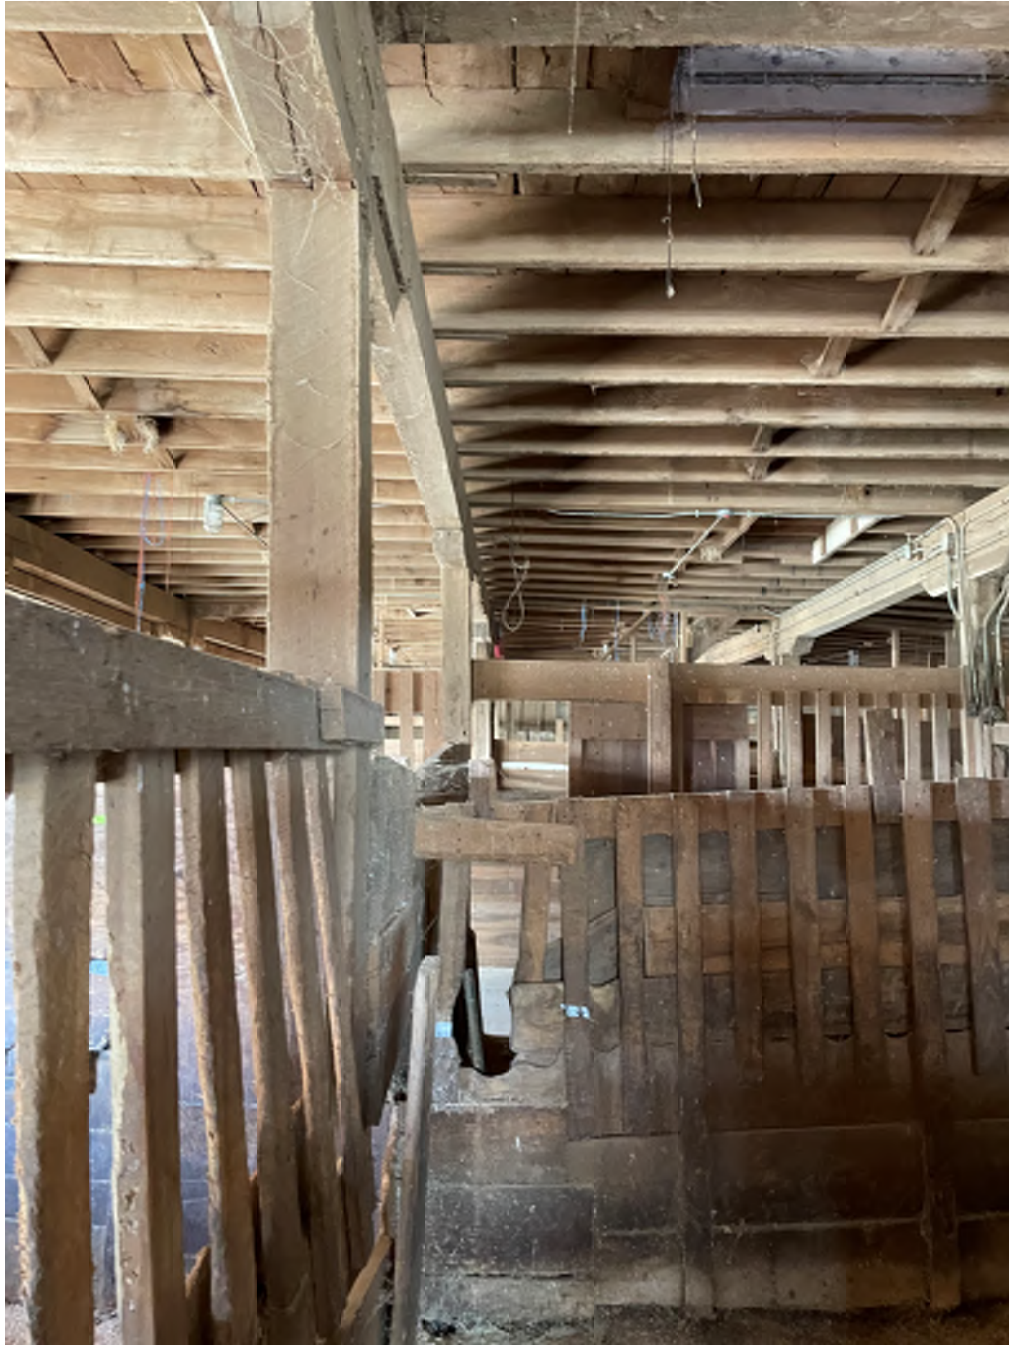
Note limited internal bracing.

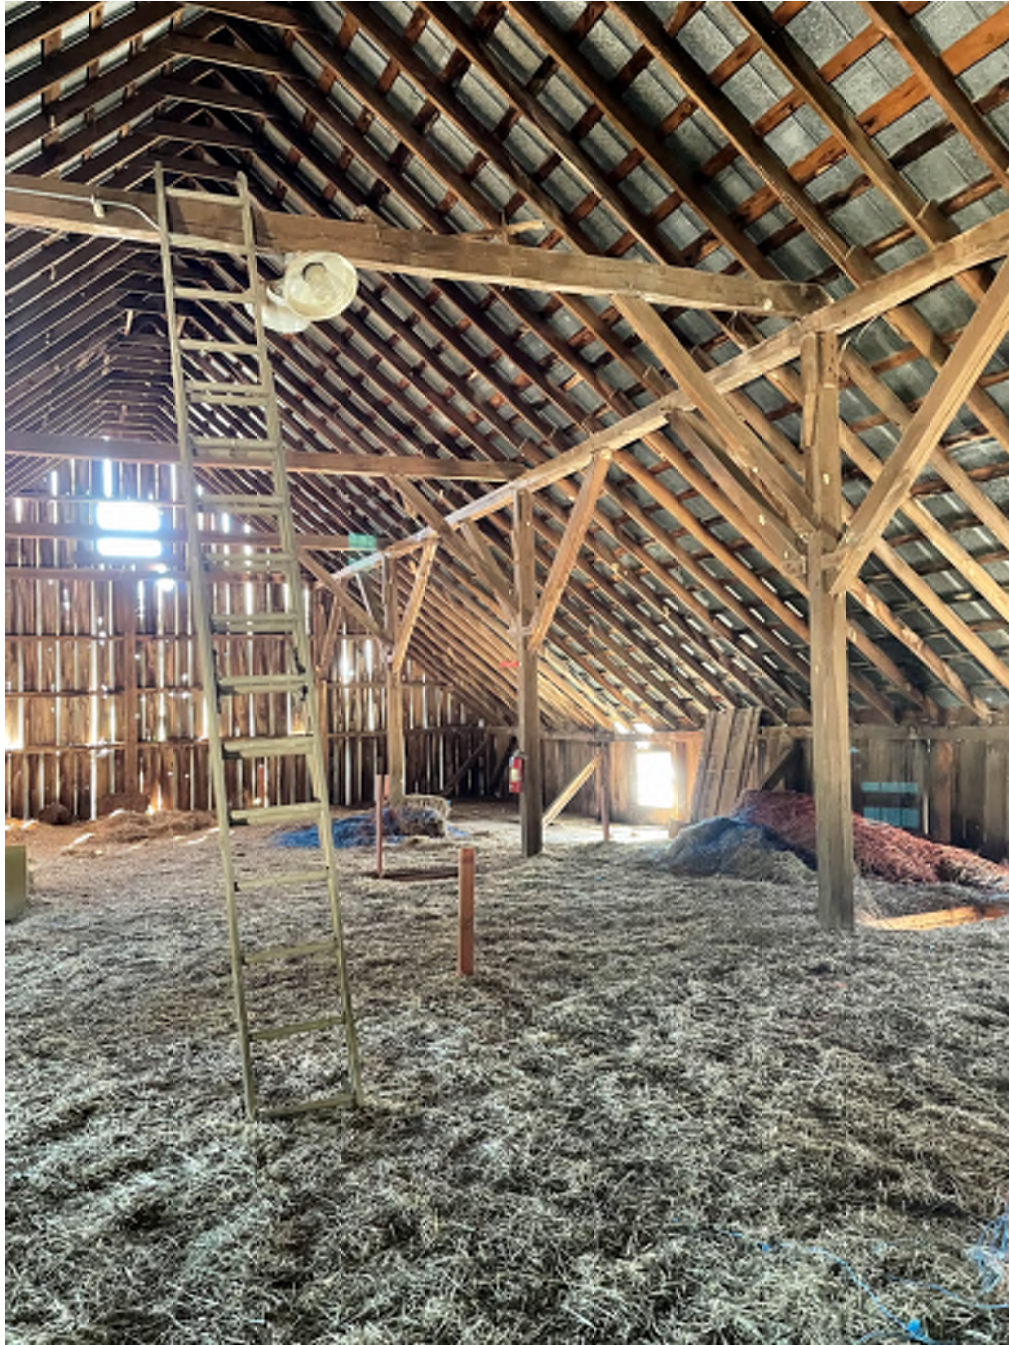
View of loft framing. Small posts on the floor indicate openings.
